AQUATICS[®]

Hidden Problems —

A Step-by-Step Guide to Pool/Spa Equipment Room Troubleshooting

TROUBLESHOOTING REPORT — VILLA PORTOFINO COMMUNITY Tierra Santa, Calif.

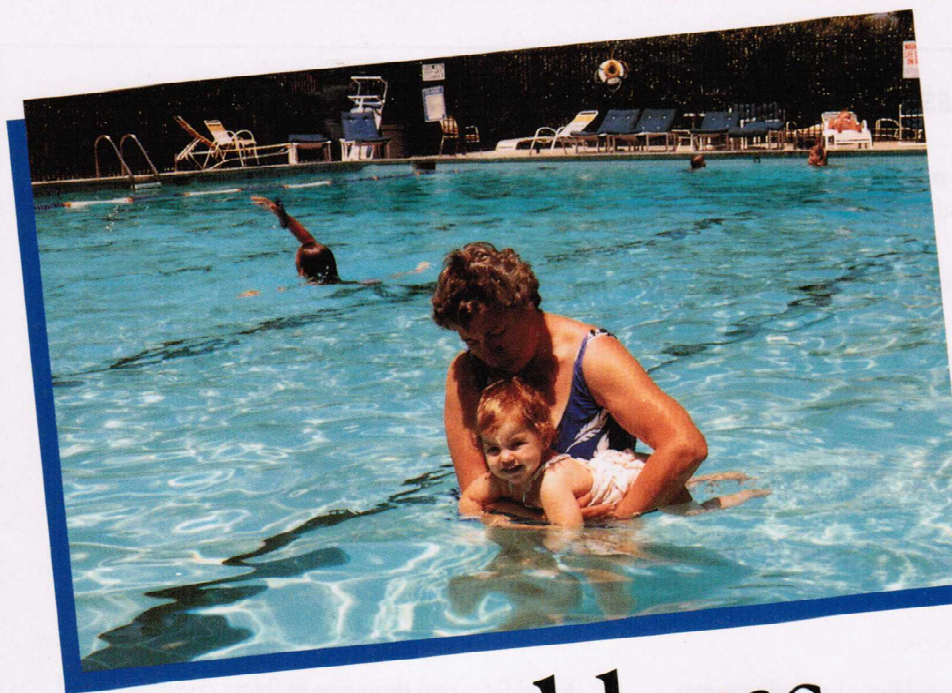
The Villa Portofino community pool receives heavy use during the summer months. Recent equipment problems led to the hiring of an outside consultant for advice.

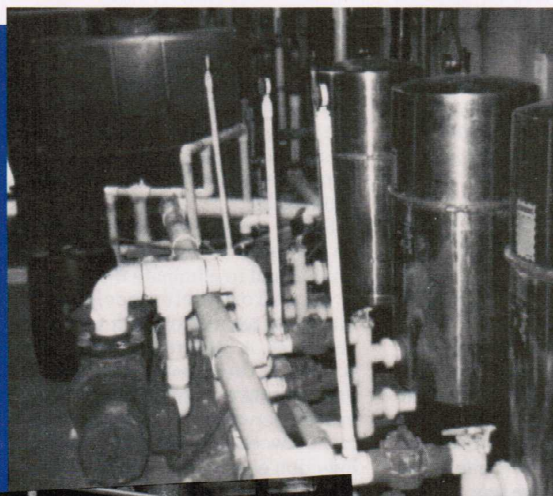
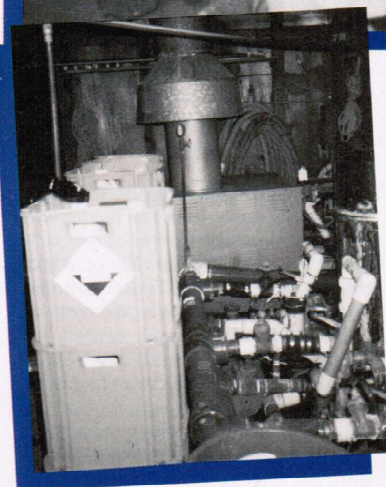
After repairs were finished, at left, the equipment room at the Villa Portofino community pool appeared neater and better organized than before, bottom left. The heater was replaced and some hazards were eliminated from the equipment room.

- The equipment room was poorly designed, laid out and maintained.
- Equipment was not adequately labeled.
- Schematic diagrams and manufacturers' operations and maintenance manuals were not available for reference.
- The pool heater had disintegrated, primarily because of improper heater in-

stallation and injection of acidic chemicals, particularly trichlor, immediately prior to the heater elements.

To correct problems and prevent their recurrence, several changes were made. A new Teledyne Laars natural gas heater was installed by an experienced vendor.

The primary bactericide was switched from trichlor to sodium hypochlorite. Chemical injection equipment was relocated to the correct position and some circulation pipes were replaced.
